Evaluation Report

Morris Genesis II MA 170 Air Seeder

MORRIS GENESIS II MA 170 AIR SEEDER

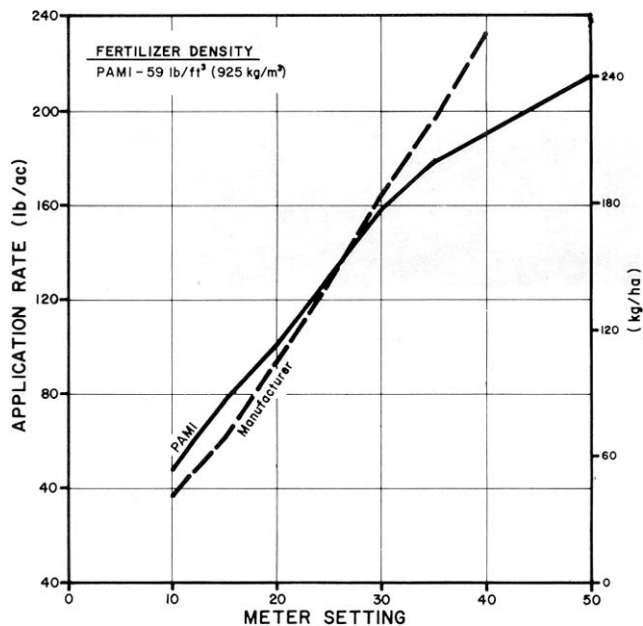
FIGURE 5. Metering Accuracy in Fertilizer.

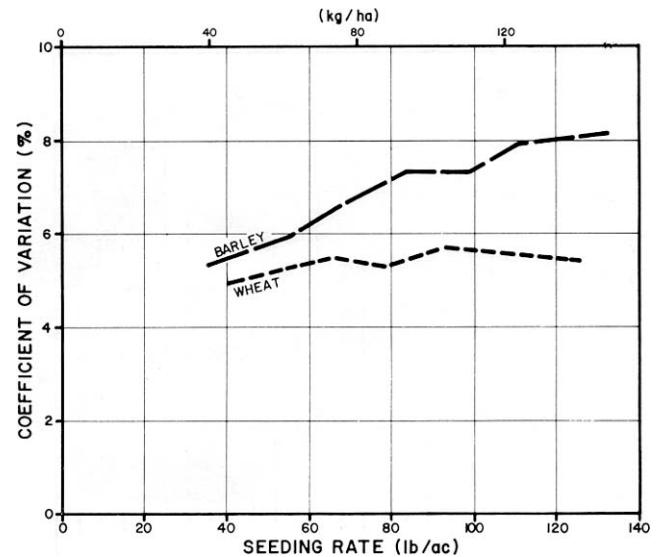
Distribution Uniformity: Uniformity of distribution of the application rate for the Genesis II MA 170 was very good. Given in FIGURE 6 is the seeding distribution uniformity for the Morris MA 170 in wheat and barley. Distribution was uniform over the full range of seeding rates. For example, at a seeding rate of 78.5 lb/ac (87.9 kg/ha), the coefficient of variation¹ (CV) was

5.3% for wheat, and at a seeding rate of 84 lb/ac (94.1 kg/ha) the CV was 7.3% for barley. FIGURE 7 shows a typical seeding distribution pattern obtained in wheat at a seeding rate of 78.5 lb/ac (87.9 kg/ha). The seeding rate from each hoe opener across the width of the air seeder varied from 70.1 to 93 lb/ac (78.5 to 104.2 kg/ha). This resulted in acceptable distribution uniformity with a CV of 5.5%.

FIGURE 6. Distribution Uniformity in Wheat and Barley over a Range of Seeding Rates.

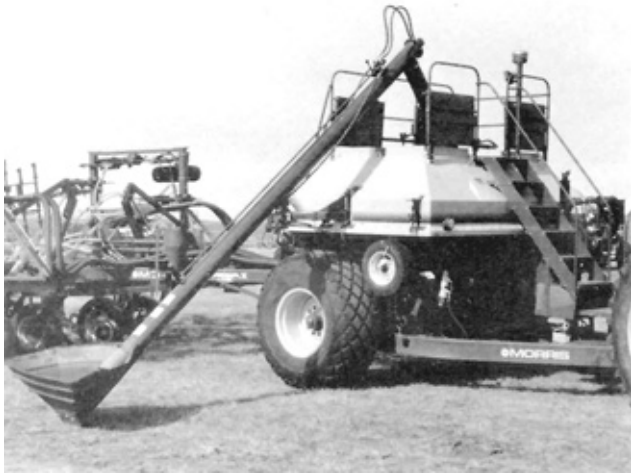
Maneuvering the auger into fill position (FIGURE 12) was difficult because of the lack of clearance between the auger spout and the tank railing. It is recommended that the manufacturer consider modifying the tank railing to allow more clearance for the auger spout while maneuvering the auger into fill position.

FIGURE 12. Fill Position of Auger.

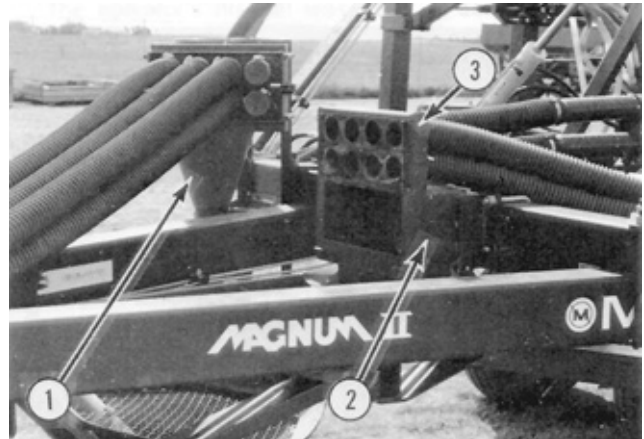
FIGURE 14. (1) Cyclone, (2) Sample Collector, (3) Air Seeder Distribution.

The MA 170 was equipped with a sample collector (FIGURE 14) used for calibrating the application rate. To use the collector, the primary hoses were lowered down and a bag or pail was used to collect the material. The handle on the metering drive wheel (FIGURE 21) was used to turn the meter shaft. A chart was provided in the operator's manual for relating the width of machine to the number of turns of the metering drive wheel in order to seed 0.25 ac (0.1 ha). This calibration method was accurate.

secured to the cultivator frame by two U-bolts as shown in FIGURE 14. Installing the delivery hoses to the front row of openers was difficult because the divider heads were located behind the front row of shanks. This required the operator to rotate the hoses back to the front row of shanks. Initial mounting took two men approximately 2 hours.

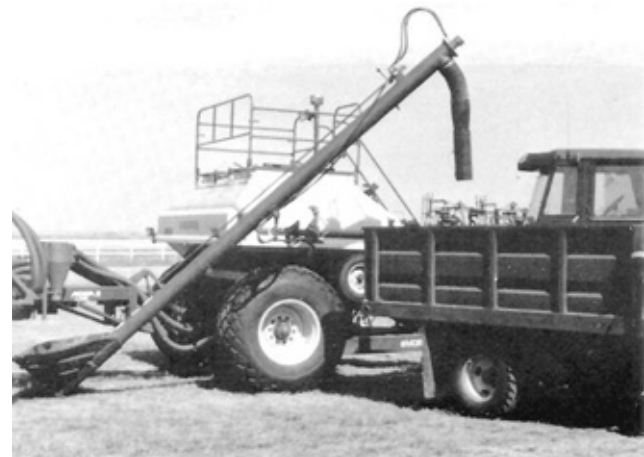
Cleaning large amounts of material out of the tanks was convenient using the clean-out system. The system was operated by disconnecting the primary hoses from the distribution system and connecting them to the cyclone as shown in FIGURE 14. The fan was used to convey the material to the cyclone. Material was dropped into the airstream by slides located near the metering cups. The slides for each tank were opened by levers located on the side of the tanks. The cyclone dropped the material into the auger hopper and the material was then augered into a truck as shown in FIGURE 15.

FIGURE 15. Using Clean-Out System.

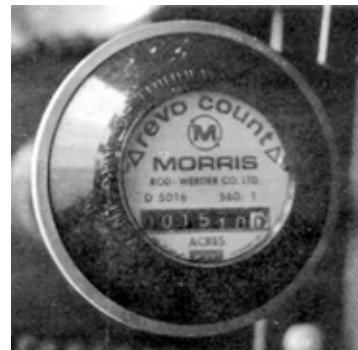
Monitoring: Monitoring on the MA 170 was fair. Monitoring equipment included motion indicators (FIGURE 17) for the meter shafts, a system pressure gauge (FIGURE 19) and the optional acremeter (FIGURE 20). The motion indicator for the front meter could be easily viewed from the tractor but the view from some tractors of the motion indicator for the rear meter was obstructed by the diesel motor. The pressure gauge was easily viewed from the tractor. The optional acremeter read 4% high.

FIGURE 20. Acremeter.

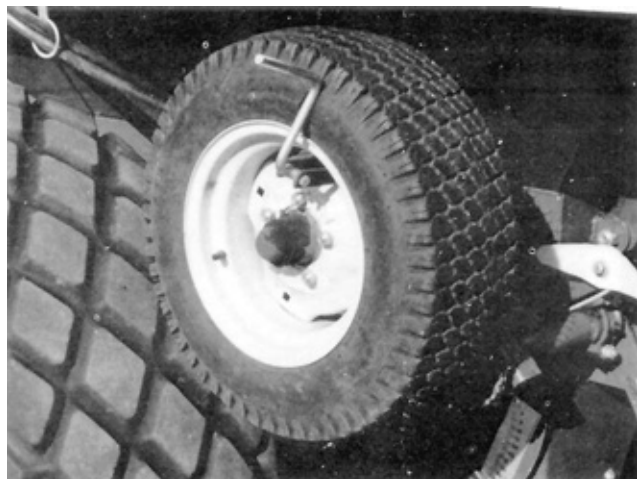
FIGURE 21. Metering Drive Wheel.
